# Manhole Inspection Summary

Manhole # S15YY\_022MH

Insp Date: **11/11/08 2:31 PM**

**Location** Address: **1888 ROCKROSE**

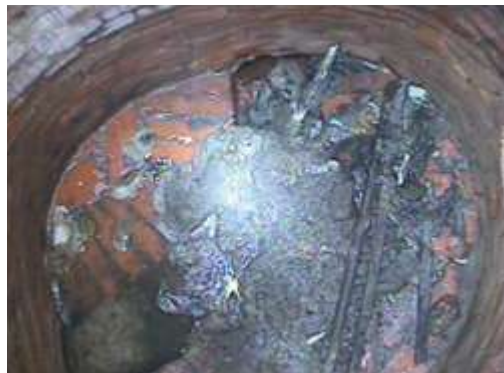
Top View

NOTE DEBRIS

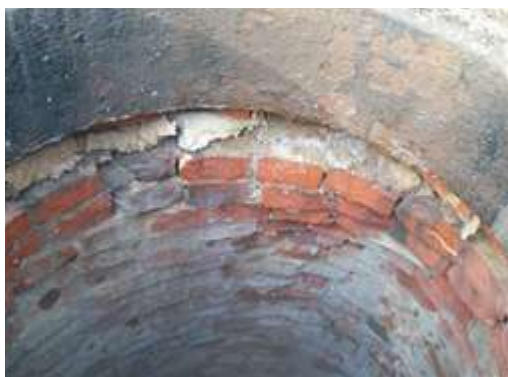
Defect 1

Condition: ☐ Sound ☒ **Cracked** ☐ Root Intrusion ☐ Loose Brick ☐ Deteriorated

CRACKED CHIMNEY

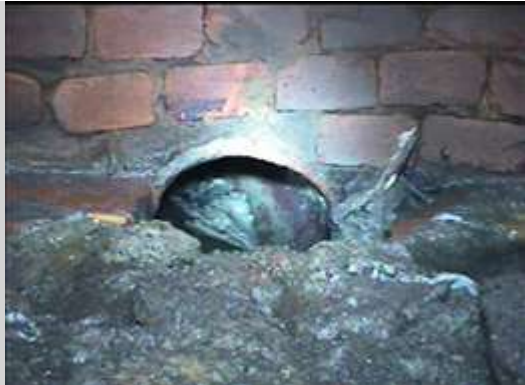
12 O'Clock Outflow

8 in. Circular Gravity Sewer  
Pipe Out @ 12 O'Clock

Pipe Height: (in.) Direct  
Pipe Material: **Clay** ☐ Pipe Lined  
Invert Depth: **6.76** (ft.) Flow Characteristics: **Slow**  
Deposits: ☐ None ☐ Mud ☐ Sludge ☒ **Debris** ☐ Grease  
Silt Depth: **3** (in.) Deposits Extent: **Medium**  
Infiltration: **None** Pipe Seal Cond: **Sound**

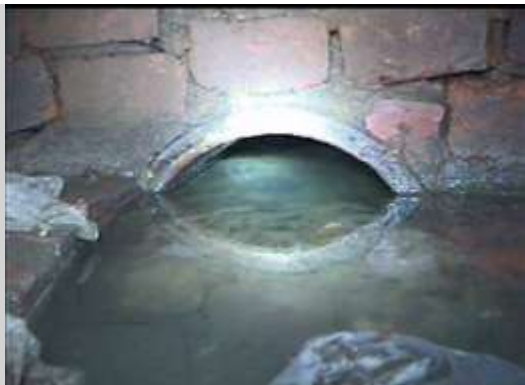
9 O'Clock Inflow

8 in. Circular Gravity Sewer  
Pipe In @ 9 O'Clock

Pipe Height: (in.) Direct  
Pipe Material: **Clay** ☐ Pipe Lined  
Invert Depth: **6.50** (ft.) Flow Characteristics: **Slow**  
Deposits: ☐ None ☐ Mud ☐ Sludge ☒ **Debris** ☐ Grease  
Silt Depth: **3** (in.) Deposits Extent: **Medium**  
Infiltration: **None** Pipe Seal Cond: **Sound**
